ANNUAL REPORT FOR 2011

**Bald Creek Site #3 Mitigation Site
Yancey County
TIP No. R-2518B**

Prepared By:
Natural Environment Unit & Roadside Environmental Unit
North Carolina Department of Transportation
December 2011

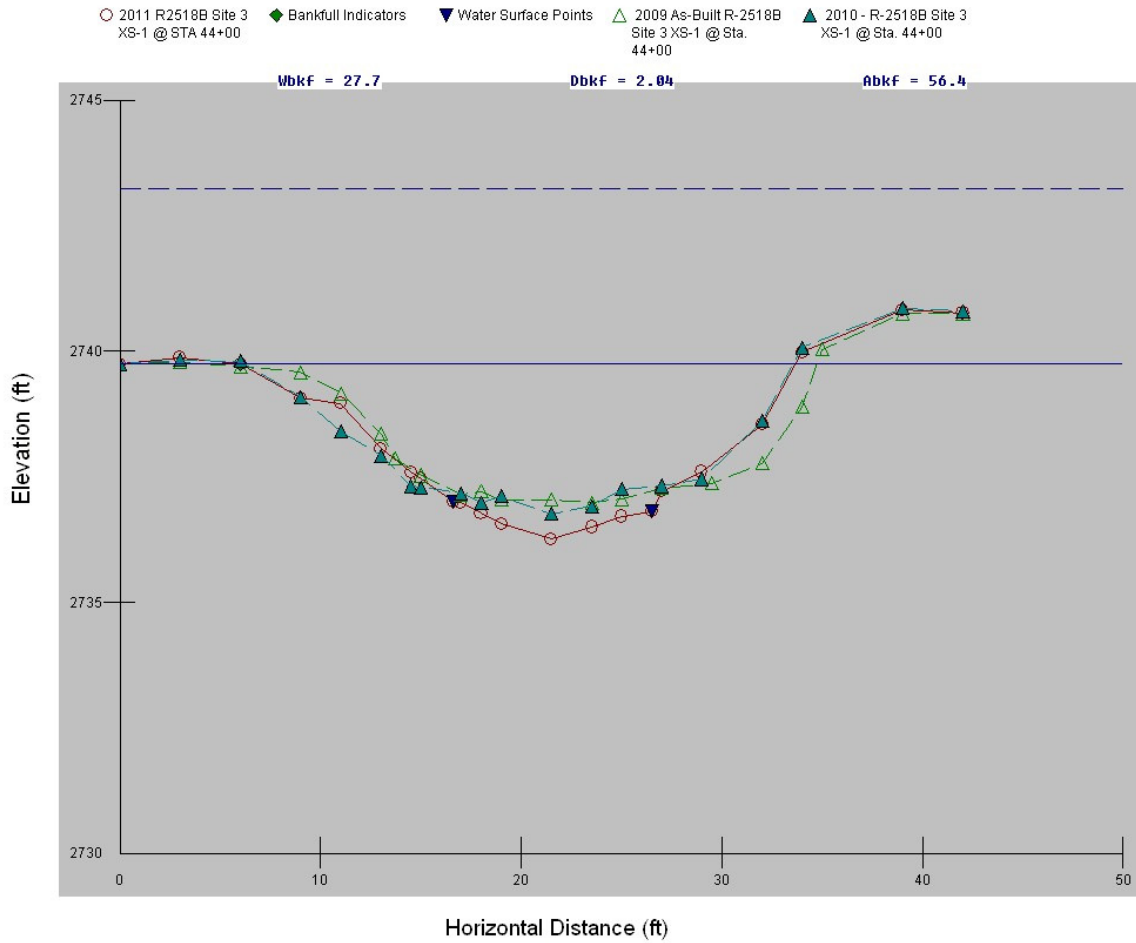
R-2518B Site 3 XS-1 @ STA 44+00

Site #3: Cross-Section #1 (Riffle) Abbreviated Morphological Summary					
	2010	2011	2012	2013	2014
Bankfull Cross Sectional Area (ft ²)	55.19	56.45			
Maximum Bankfull Depth (ft.)	3.05	3.49			
Width of the Floodprone Area (ft.)	42	42			
Bankfull Mean Depth (ft.)	1.85	2.04			
Width/Depth Ratio	16.16	13.57			
Entrenchment Ratio	1.4	1.52			
Bankfull Width (ft.)	29.89	27.68

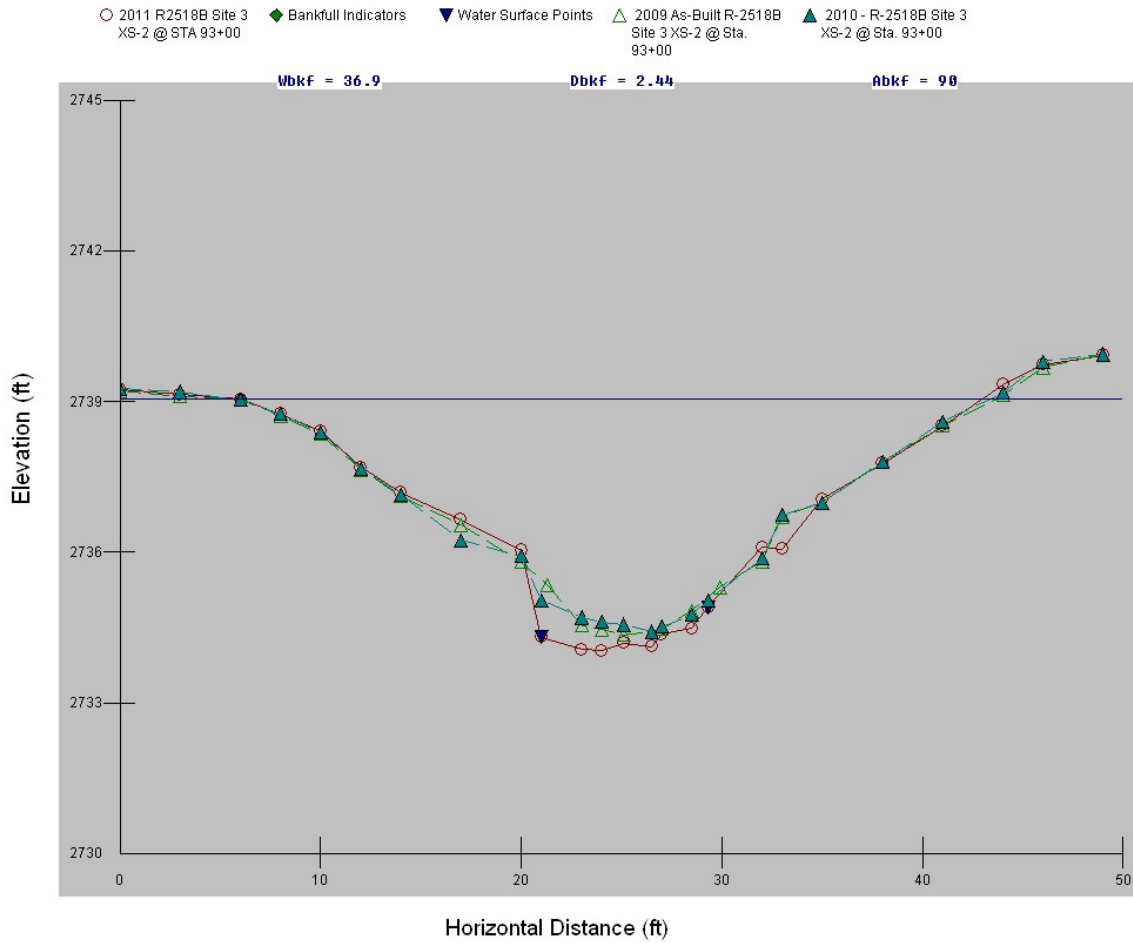
R-2518B Site 3 XS-2 @ STA 93+00

Site #3: Cross-Section #2 (Pool) Abbreviated Morphological Summary*					
	2010	2011	2012	2013	2014
Bankfull Cross Sectional Area (ft ²)	86.6	90.04			
Maximum Bankfull Depth (ft.)	4.61	5.0			
Bankfull Mean Depth (ft.)	2.32	2.44			
Bankfull Width (ft.)	37.26	36.9

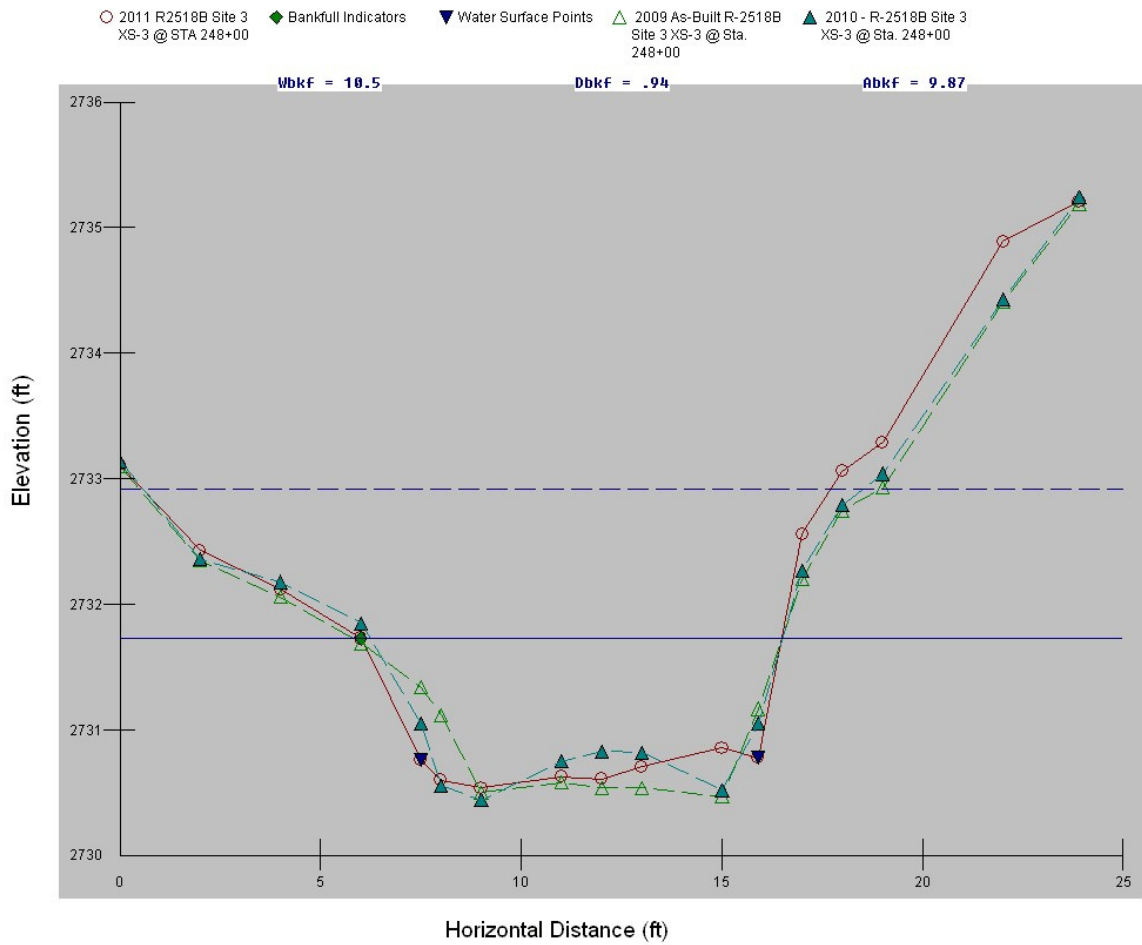
R-2518B Site 3 XS-3 @ STA 248+00

Site #3: Cross-Section #3 (Riffle) Abbreviated Morphological Summary					
	2010	2011	2012	2013	2014
Bankfull Cross Sectional Area (ft ²)	10.67	9.87			
Maximum Bankfull Depth (ft.)	1.41	1.19			
Width of the Floodprone Area (ft.)	19.47	17.16			
Bankfull Mean Depth (ft.)	1.01	0.94			
Width/Depth Ratio	10.51	11.16			
Entrenchment Ratio	1.83	1.64			
Bankfull Width (ft.)	10.62	10.49

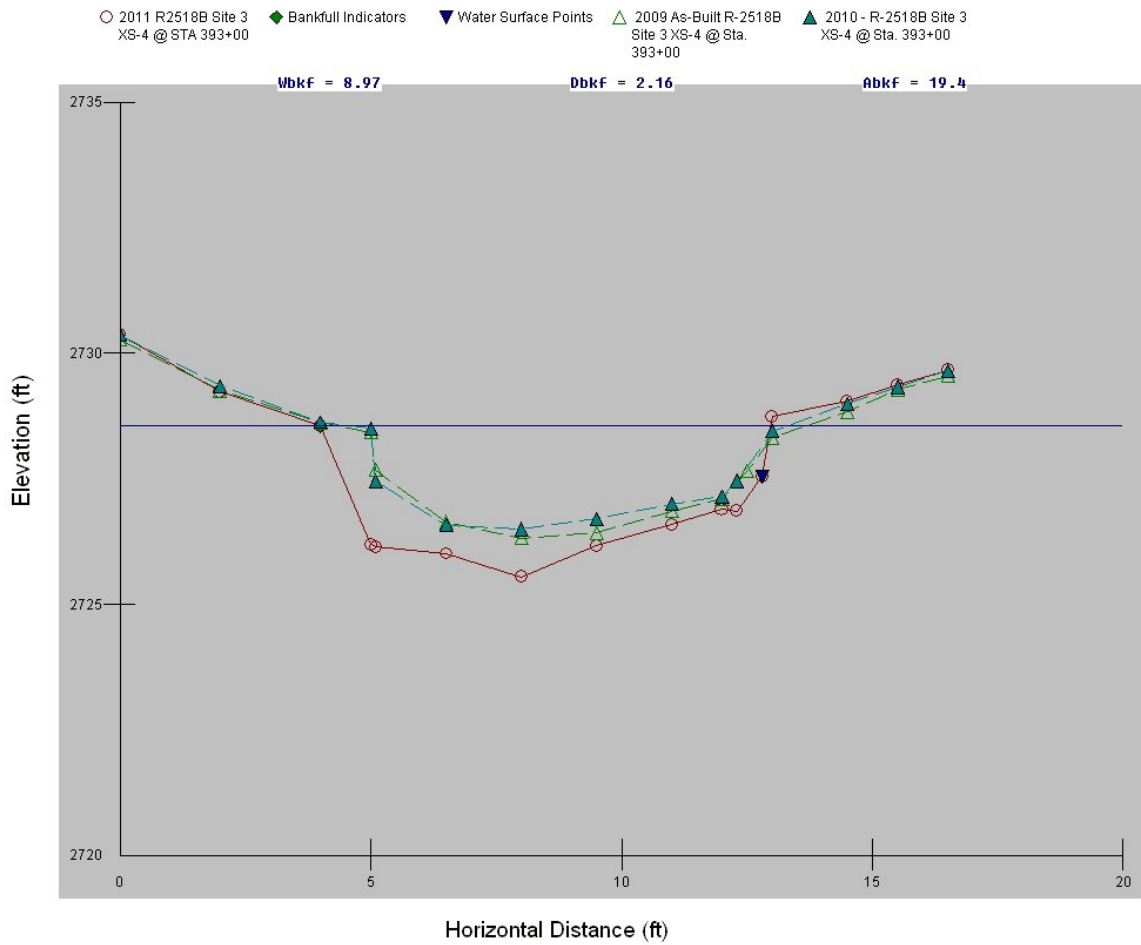
R-2518B Site 3 XS-4 @ STA 393+00

Site #3: Cross-Section #4 (Pool) Abbreviated Morphological Summary*					
	2010	2011	2012	2013	2014
Bankfull Cross Sectional Area (ft ²)	12.56	19.4			
Maximum Bankfull Depth (ft.)	2.0	3			
Bankfull Mean Depth (ft.)	1.54	2.16			
Bankfull Width (ft.)	8.14	8.97
